Retford Circular Economy Project Environmental Statement Addendum – Volume 3 Technical Appendices

Technical Appendix 8.8: Bat Roost
Assessment

January 2024

Tree Climbing Survey Retford Circular Economy Project

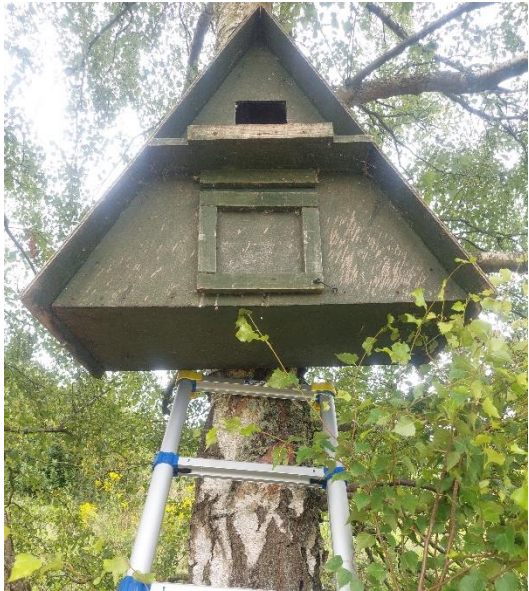
Feature ID / Grid Ref.	Description of features and summary of assessment	Photo
<p>Tree 5 SK6973185109</p>	<p>Birch tree with no features suitable for roosting bats.</p> <p>Barn owl box on north eastern aspect, accessed by ladder. Dead barn owl chick within box considered to be 25-43 days old; small to medium number of feathers on tail, flight feathers emerged from pins.</p> <p>Confirmed barn owl breeding from 2023 season. Two wood pigeons also using box.</p> <p>Previous BRP: Moderate Updated BRP: Negligible</p>

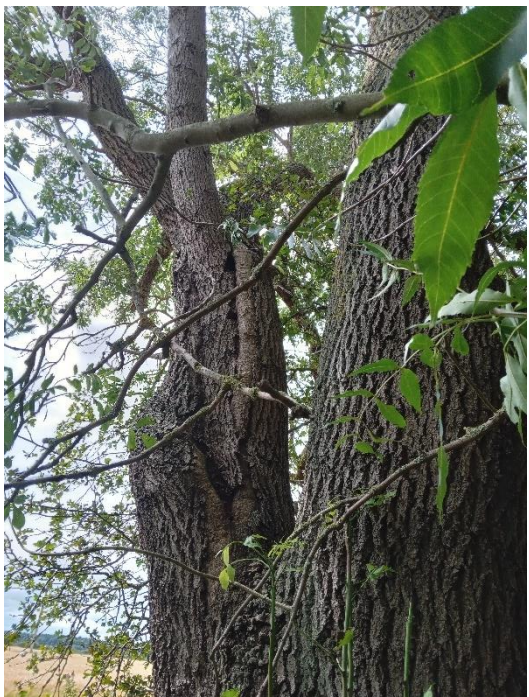
<p>Tree 6 SK6850883435</p>	<p>Ash tree with knot holes and tear-out feature on western and northern-eastern aspects, 2-3m high, accessed by ladder and inspected using an endoscope.</p> <p>Features largely superficial and not leading to notable cavities. Blue tit feathers present in larger of two cavities associated with tear-out, but no evidence of nesting.</p> <p>Previous BRP: Moderate Updated BRP: Low</p>

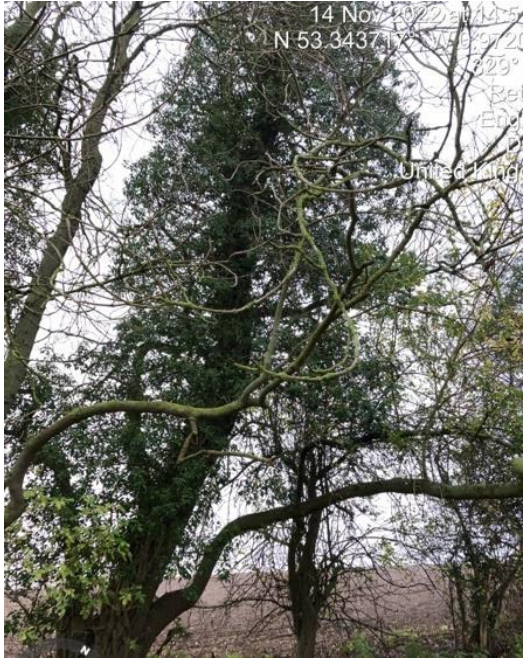
Feature ID / Grid Ref.	Description of features and summary of assessment	Photo
<p>Tree 7 SK6853983474</p>	<p>Ash tree with dense ivy cladding on entire tree. Spindly structure and not considered safe to climb due to limited visibility of anchor points, typical brittle nature of ash trees and poor condition of surrounding trees of a similar species/ structure.</p> <p>No features were identified from the ground; however, full inspection not possible therefore precautionary low suitability maintained.</p> <p>Previous BRP: Low Updated BRP: Low</p>

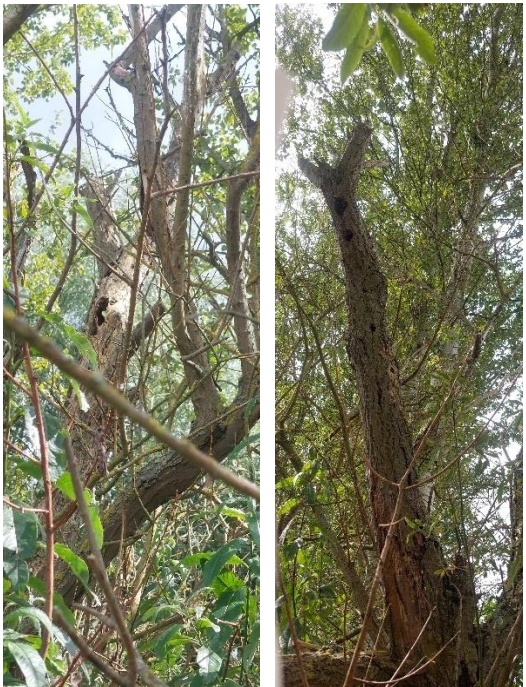
<p>Tree 10 SK6880883928</p>	<p>Multi-stem willow with all limbs decaying and rotten. Not able to climb or inspect using ladder due to fragility of tree.</p> <p>Most limbs hollow and deteriorating rapidly, creating a very limited number of exposed features.</p> <p>Previous BRP: Low Updated BRP: Low</p>

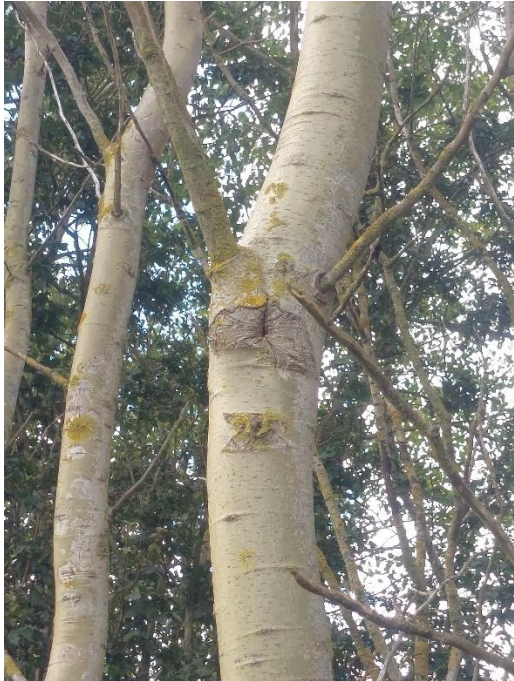
Feature ID / Grid Ref.	Description of features and summary of assessment	Photo
<p>Tree 11 SK6878184203</p>	<p>Birch tree with historic wound approximately 3m high on south-eastern aspect, that has since healed, and been almost completely sealed by new growth.</p> <p>No other features present, therefore no aerial inspection required.</p> <p>Previous BRP: Low Updated BRP: Negligible</p>

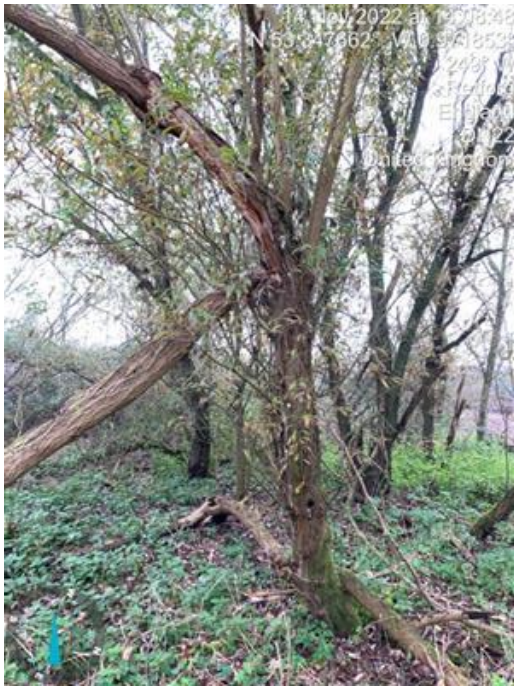
<p>Tree 12 SK6854183912</p>	<p>Willow tree with two knot holes at 1m and 2m high, on the western aspect. Features inspected from the ground using an endoscope; neither formed a significant cavity and were not considered to have any suitability for roosting bats.</p> <p>Tear-out on upper limb was superficial and offered no roosting opportunity.</p> <p>Previous BRP: Moderate Updated BRP: Negligible</p>

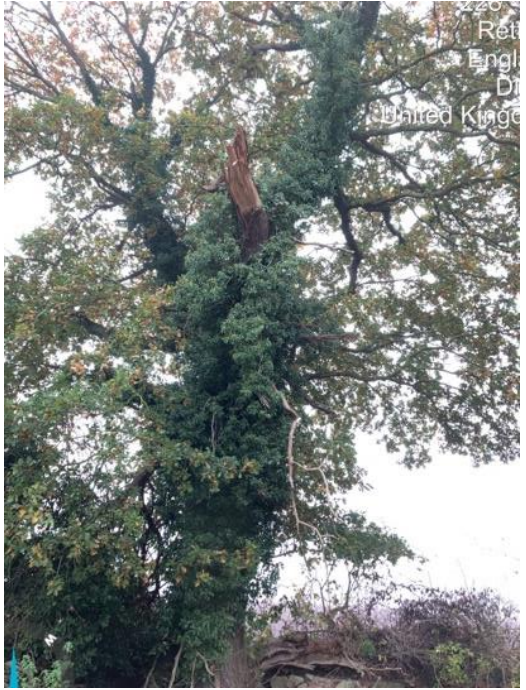
Feature ID / Grid Ref.	Description of features and summary of assessment	Photo
<p>Tree 13 SK6854583439</p>	<p>Oak tree with dense ivy cladding on main stem and throughout canopy. Ivy creates a cluttered access route for aerial assessment; not possible for surveyors to secure a safe top rope close to main stem.</p> <p>Features visible from the ground include tear-outs on two branches, facing north-west and south-east, creating horizontal cracks. Features extend outwards beyond the ivy therefore allowing uncluttered access for bats; however, roost suitability of features not thoroughly examined. Features too high in tree to assess using ladder.</p> <p>Previous BRP: Moderate Updated BRP: Moderate</p>

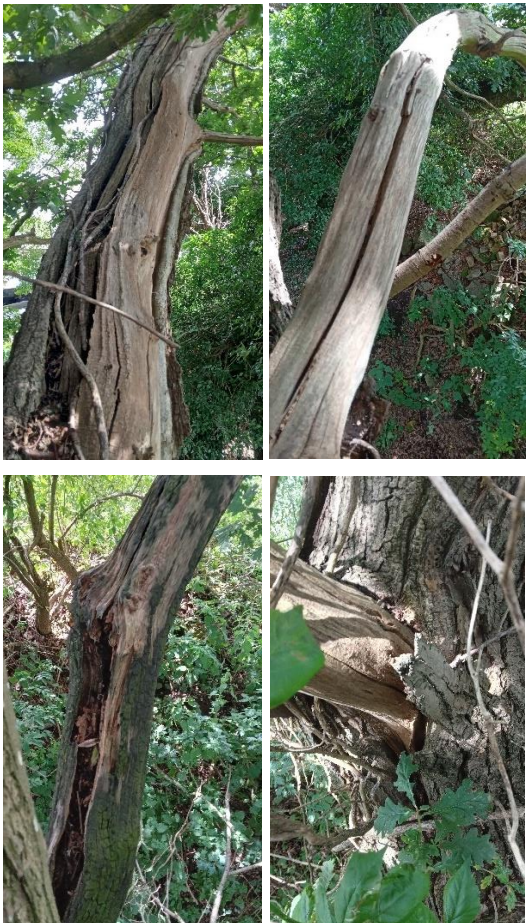
<p>Tree 14 SK6852983438</p>	<p>Oak tree with fire-damaged lower limbs. Some minor decay at base of tree, but not significant.</p> <p>Tree accessed using ropes, but only via main stem due to dead limbs. Features examined included peeling bark and cracks present on lower limbs 4-5m high, south and south-east facing; most of which were superficial or filled with woodlouse. Some upward-facing splits in deadwood present, likely a result of squirrel damage, also superficial.</p> <p>Previous BRP: Low Updated BRP: Low</p>

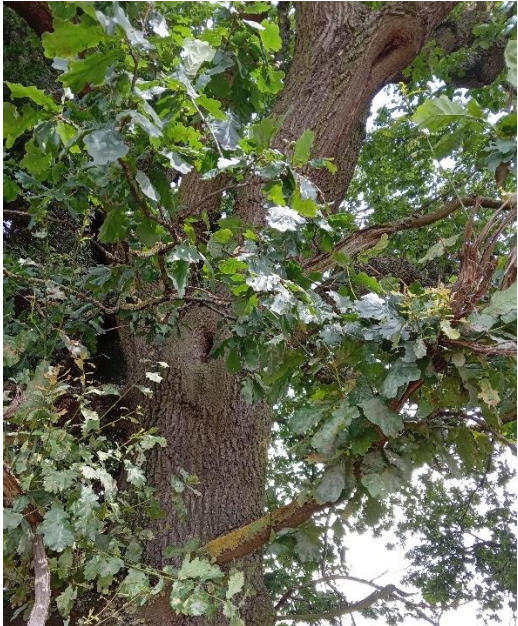
Feature ID / Grid Ref.	Description of features and summary of assessment	Photo
<p>Tree 15 SK6853983443</p>	<p>Oak tree with dense ivy cladding. Ivy creates a cluttered access route for aerial assessment; not possible for surveyors to secure a safe top rope close to main stem.</p> <p>No features other than the ivy itself were identified from the ground; however, full inspection not possible therefore precautionary low suitability maintained.</p> <p>Previous BRP: Low Updated BRP: Low</p>	<p>No photo taken.</p>
<p>Tree 16 SK6858283380</p>	<p>Oak tree with two knot holes on western and south-western aspect of main stem, 4m and 5m high. The feature at 4m was shallow and exposed, heavily cobwebbed and full of ants. The feature at 5m did not extend a sufficient depth into the stem to create a suitable feature.</p> <p>Tree was climbed using ropes and inspected with an endoscope.</p> <p>Previous BRP: Moderate Updated BRP: Low</p>

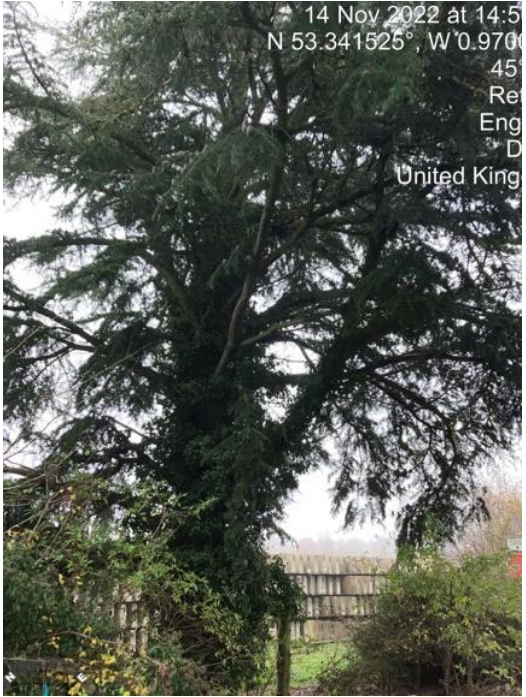
Feature ID / Grid Ref.	Description of features and summary of assessment	Photo
<p>Tree 17 SK6867383236</p>	<p>Atlas cedar with dense ivy cladding. Not climbed due to close proximity to road, and frequent trucks passing associated with adjacent concrete plant.</p> <p>A cedar of this size and condition was considered unlikely to possess any notable decay features, some pruned branches were present; however, these were cleanly cut with no rot. The ivy did not appear mature enough to form plating; however, it was not possible to fully assess the entirety of the tree from the ground due to the dense canopy.</p> <p>Previous BRP: Low Updated BRP: Low</p>

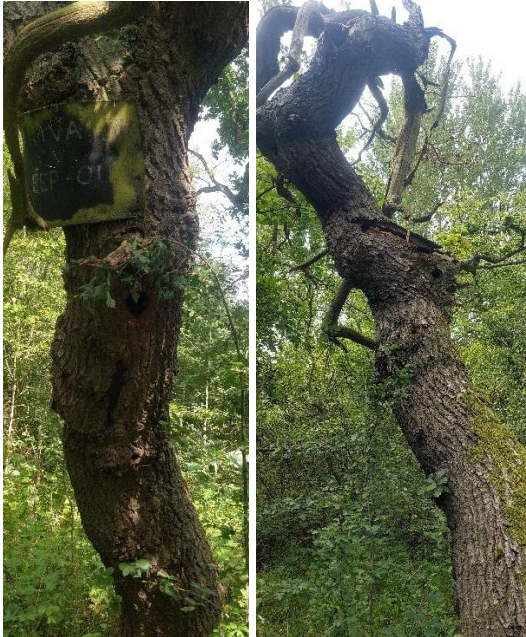
<p>Tree 18 SK6908484079</p>	<p>Oak tree, almost entirely dead, with a knot hole on western aspect and split bark at the upper extent of the eastern aspect of main stem. Not climbed due to lack of anchor points and presence of honey bees in upper feature.</p> <p>Knot hole at 2m high inspected with endoscope; feature comprised a domed cavity descending approximately 30cm down the stem, with an internal diameter of 8cm, and separate from the higher feature. Relatively open and exposed entrance. Bird nesting material was present at the base of the cavity.</p> <p>Previous BRP: Low Updated BRP: Low</p>

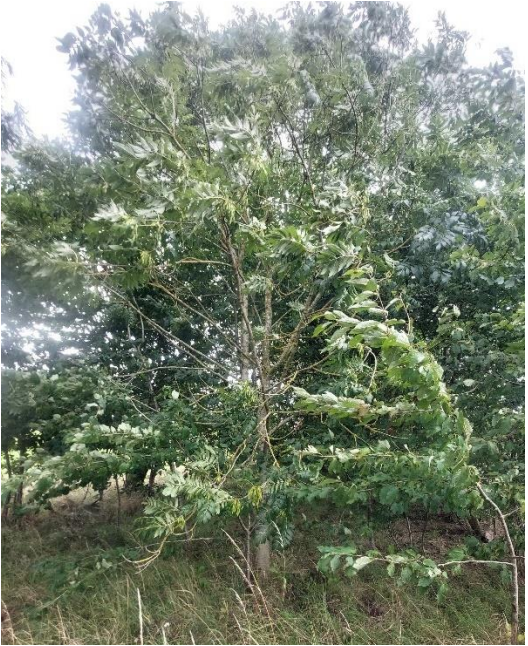
Feature ID / Grid Ref.	Description of features and summary of assessment	Photo
<p>Tree 19 SK6927684704</p>	<p>Previously recorded as ash tree with branch tear-out. No ash tree with any such feature was present in this location during the survey. Two semi-mature ash trees present in close proximity to grid reference; however, neither presented any potential roost features. No stumps present to indicate removal of trees, or evidence of fallen trees. Photo reference of closest existing ash tree to given location.</p> <p>Previous BRP: Low</p> <p>Updated BRP: Negligible (assigned to two semi-mature ash present)</p>

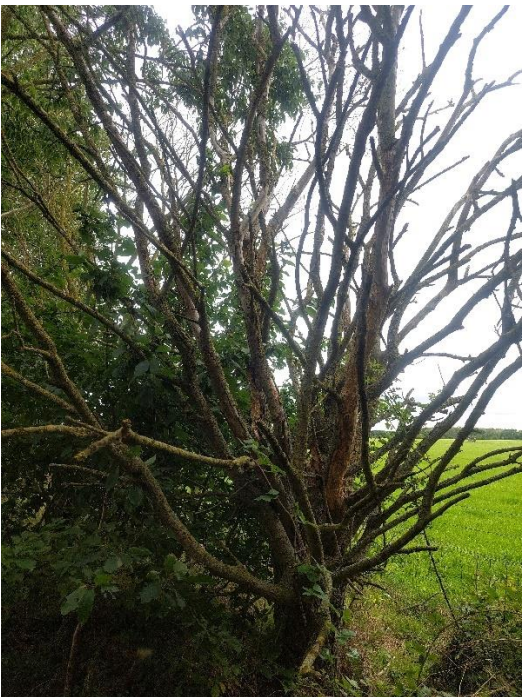
<p>Tree 20 SK6948184823</p>	<p>Dead standing tree, likely willow, not climbed due to brittle nature of remaining branches. Lifted bark throughout tree; however, all in instances features created are superficial and do not lead to any cavities suitable for roosting. Due to the condition of the tree, features are likely decaying rapidly and have become too open and exposed.</p> <p>Previous BRP: Low</p> <p>Updated BRP: Negligible</p> <p>NB. A number of similar willow trees were present along this field boundary.</p>

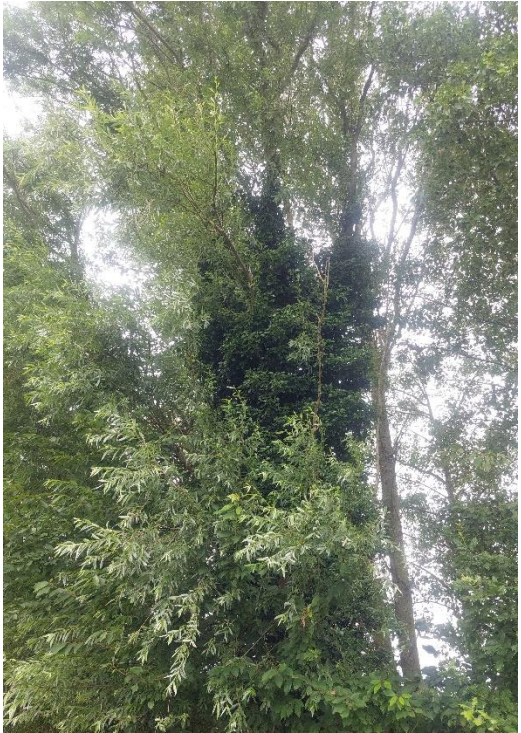
Feature ID / Grid Ref.	Description of features and summary of assessment	Photo
<p>Tree 21 SK6923585072</p>	<p>Willow with dense ivy cladding and cluttered canopy. No side branches of a sufficient diameter suitable for use as anchor points present within tree, therefore tree not climbed. Ivy stems not mature enough to create a feature in their own right, and the tree appears to be of a size and age where damage/decay features are unlikely to be present beneath the ivy.</p> <p>Previous BRP: Low Updated BRP: Negligible</p>

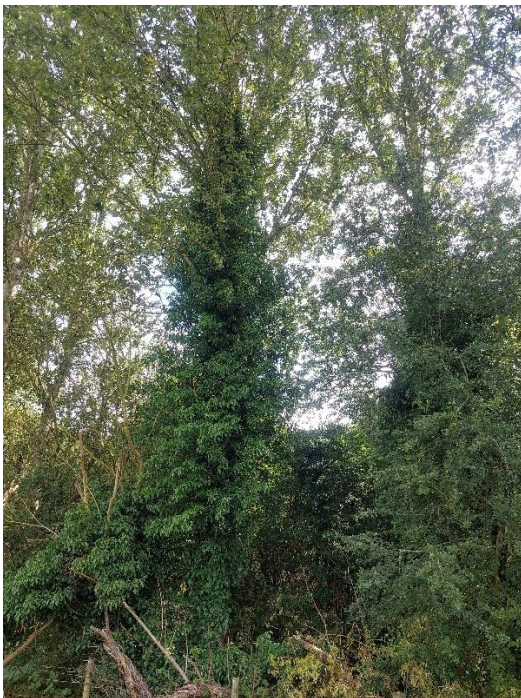
<p>Tree 22 SK6866583916</p>	<p>Three poplar trees with dense ivy cladding. Typical poplar growth form with spindly, brittle limbs. No side branches of a sufficient diameter suitable for use as anchor points present within each tree, therefore trees not climbed. Ivy stems not mature enough to create a feature in their own right, and based on the species of the trees, their age and condition, and the lack of potential roost features on similar trees nearby, it was considered unlikely the three trees possessed suitable features beneath the ivy.</p> <p>Previous BRP: Low Updated BRP: Negligible</p>

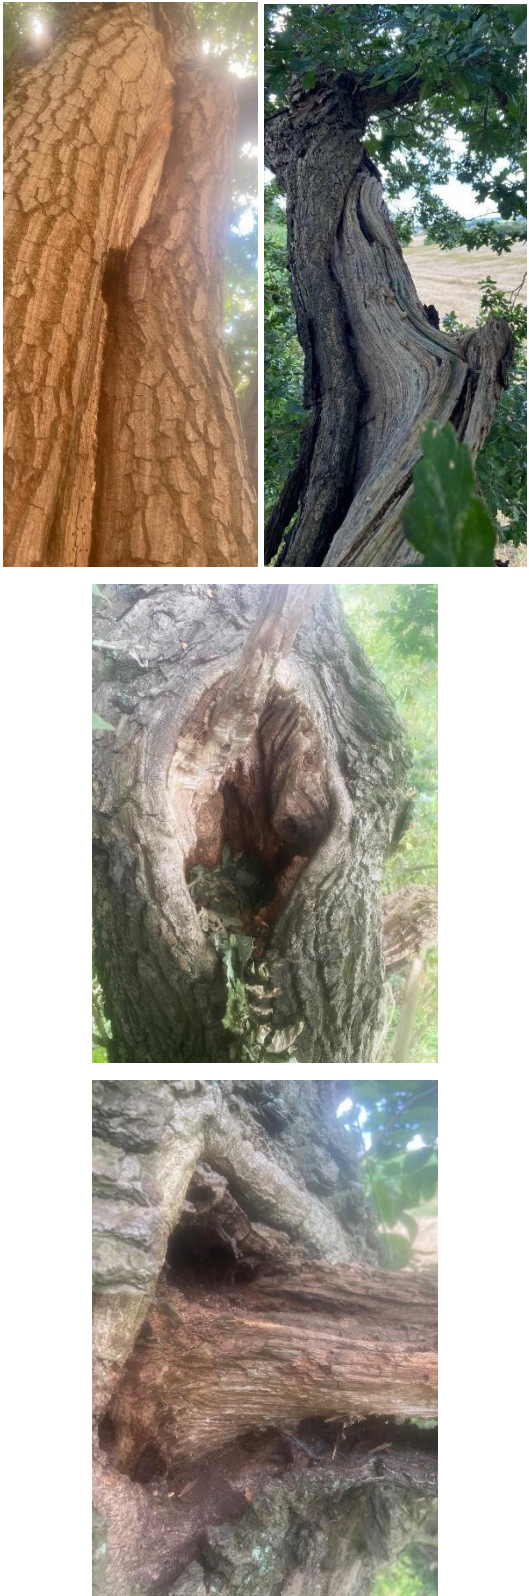
Feature ID / Grid Ref.	Description of features and summary of assessment	Photo
<p>Tree 23 SK6854983618</p>	<p>Oak tree with multiple potential roost features considered suitable for small numbers or individual bats, occasionally. Due to the close proximity to power lines to the east of the tree, the use of throw lines was considered appropriate following the risk assessment, therefore the tree was accessed using a ladder and the climber secured with ropes.</p> <p>Features included an upward-facing lightning strike present on western limb, 5m high, with flaking bark and rolled edges, but considered shallow and exposed.</p> <p>Large knot hole present on the western aspect at 5m; damp and rotted, and filled with debris and slugs.</p> <p>Lightning strike feature with rotted wood on the eastern aspect at 6m; 50cm in length but shallow and no notable cavity present.</p> <p>Rot hole on the northern aspect of a southern limb at 4m high; 40cm in diameter with squirrel nesting material.</p> <p>Rot hole on the western aspect of a southern limb at 4m high; less than 5cm internal diameter and full of woodlice.</p> <p>Knot hole on the eastern aspect of a northern limb at 5m high; an internal height of 18cm but descends into sludge.</p> <p>Previous BRP: Moderate Updated BRP: Moderate</p>

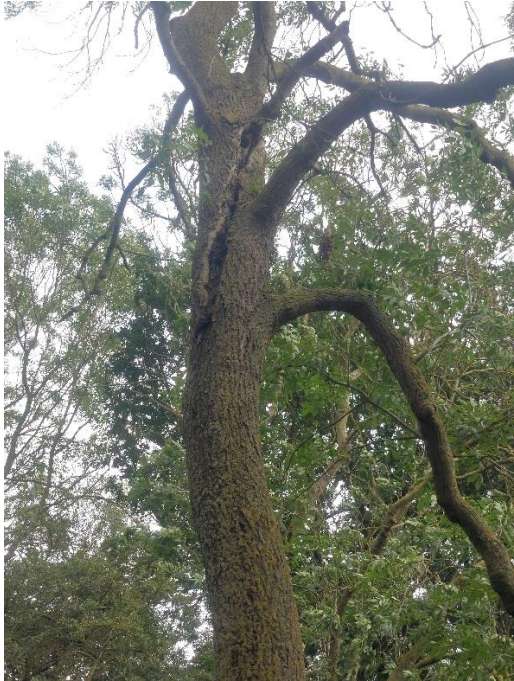
Feature ID / Grid Ref.	Description of features and summary of assessment	Photo
New tree SK6851983451	Ash tree with significant deadwood in canopy and woodpecker holes in main stem. Due to presence of ash die-back and evident decay in stem, tree was not considered safe to climb. Not previously mapped. BRP: Low
