# TECHNICAL APPENDIX 7.8 ARBORICULTURAL REPORT to BS 5837:2012 at:

# Land off Lound Low Road, Sutton cum Lound, DN22 8SB

Reference: AWA4613

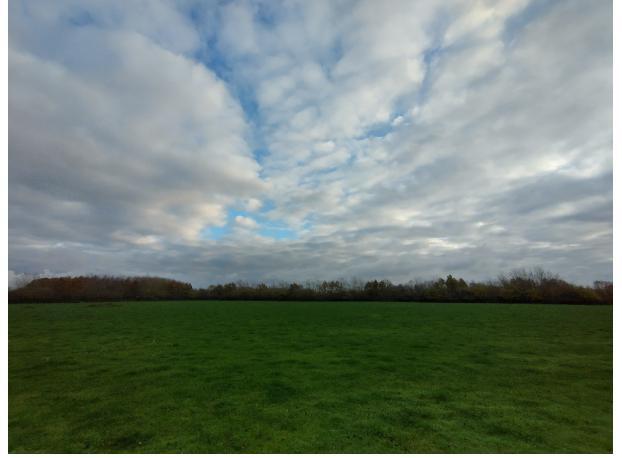
Photo 1: G8 and G30 looking south

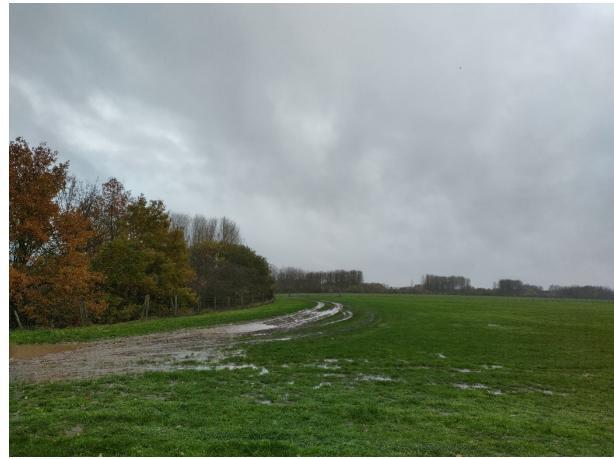
Photo 2: G33-G41 looking south

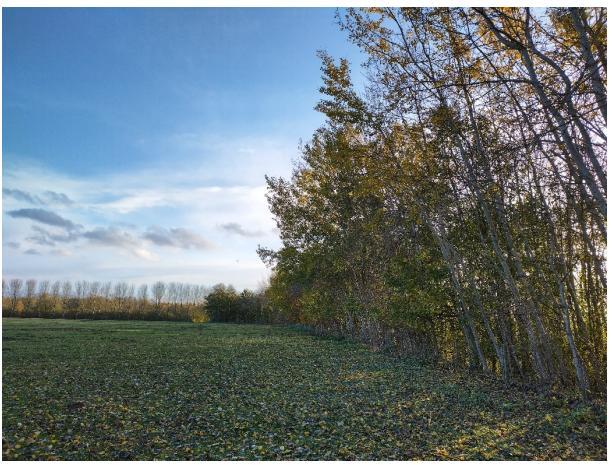
Photo 3: G59 and G60 looking south

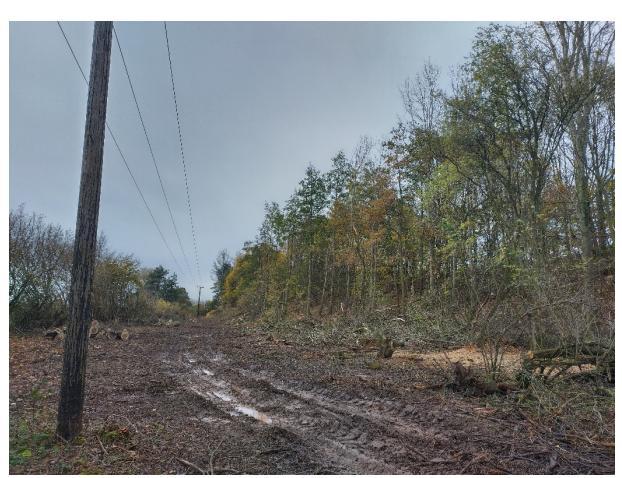
- 3.2.8 The trees situated at the southern western side of the site G51, G52, T53, T54, T55, G57, T58, G59, G61, T62, G63, T64, T66, G67, and G68 have suffered poor pruning practices, which is a result from recent cutting back from the power lines. However, they still provide adequate screening and therefore have a moderate amenity value.

Photo 4: T53-T55, G57, and G59 looking north

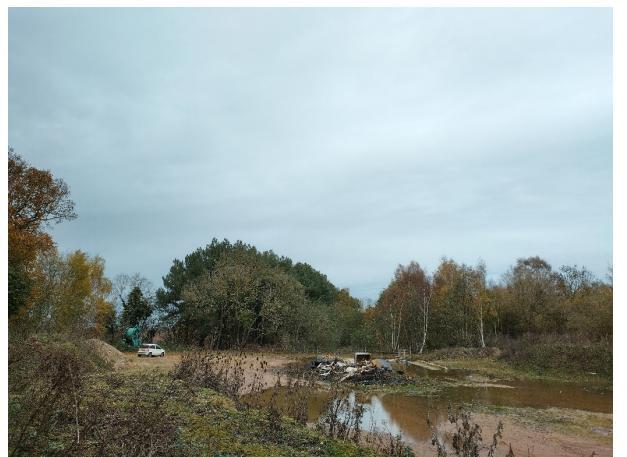
- 3.2.6 Most of the trees are young or semi-mature with only occasional early mature to mature trees.
- 3.2.7 The sites most significant tree is T72, a mature Oak. Situated to the south of the site. This tree is prominent throughout the southern area of the site and surrounding area and provides a moderate level of amenity value.

- 3.2.10 The other higher value trees are generally situated in the southern areas of the site. G67 is the group of most arboricultural significance on site; a group of early-mature Scots Pines in good condition and providing moderate amenity value. Other trees of arboricultural significance include T56, T64, T66, T70, T72, T75, and T78, generally situated along the site's boundaries and in good condition.

Photo 5: G67-T72 looking north west

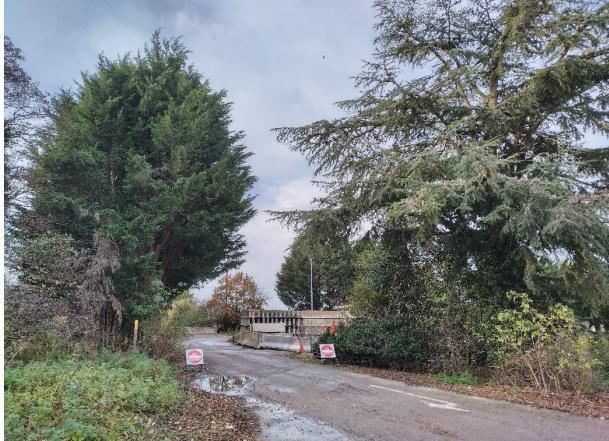
Photo 6: G76, T77, and T78 looking west
