# Retford Circular Economy Project Environmental Statement Addendum – Volume 3 Technical Appendices

Technical Appendix 9.5: RCEP PFA  
Lagoons – Bund Stability Analysis

## Bund Stability Analysis

SLR Project No.: 416.064860.00001

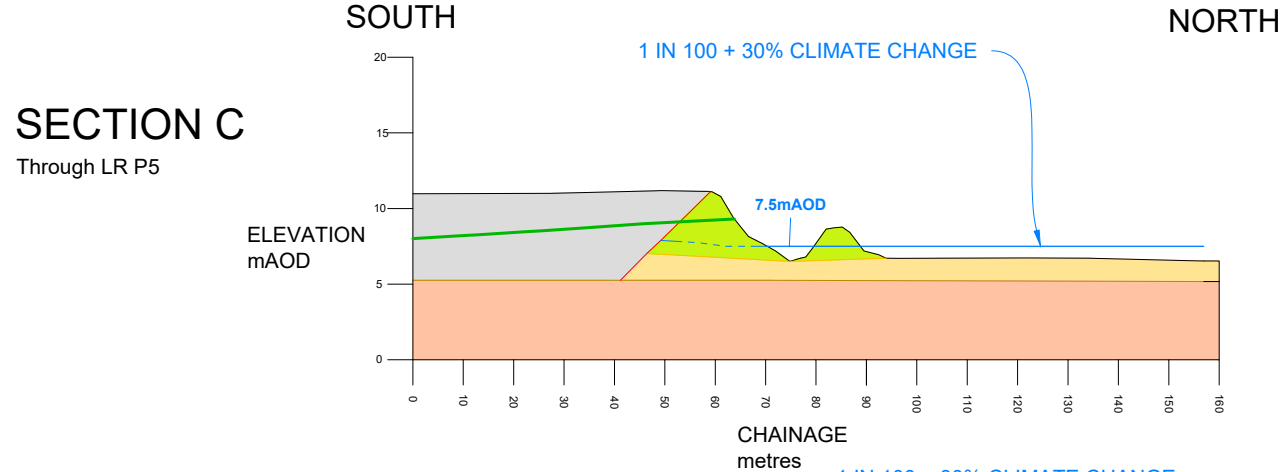
**3 X VERTICAL EXAGGERATION**

The proposed area within the Site for extraction of PFA and subsequent restoration ('Area A') comprises predominantly pastureland. The Site comprises an area of topographically elevated land ('High Rise'), formed by tipped PFA retained by engineered sandstone bunds, and the remaining c. 1/3<sup>rd</sup> of lower ground ('Low Rise') in the northeast of the Site. The PFA was piped in slurry form into previously worked sand and gravel quarries. The topographic elevations around the Site lie around 8-10m AOD, and it is assumed that the ground levels prior to the original quarrying were similar to the surrounding areas. The High Rise has been built up 8-10m above the surrounding area, whereas the Low Rise is c.1-2m higher than the surrounding area. Drawing 017A & 017B illustrate the layout of the sandstone bunds in plan and cross section respectively.

Following discussions with ERM (the project's environmental consultant); a series of cross sections were generated, as shown in Appendix A. Sections B and D have been used in the stability analysis, where the crest of the embankment and PFA sits at 11.2m and 17.3m AOD. Flood levels have been assumed to reach a maximum of 9.60m AOD in both of the sections analysed.
