Retford Circular Economy Project Environmental Statement Addendum – Volume 3 Technical Appendices

Technical Appendix 8.8: Bat Roost
Assessment

January 2024

Tree Climbing Survey Retford Circular Economy Project

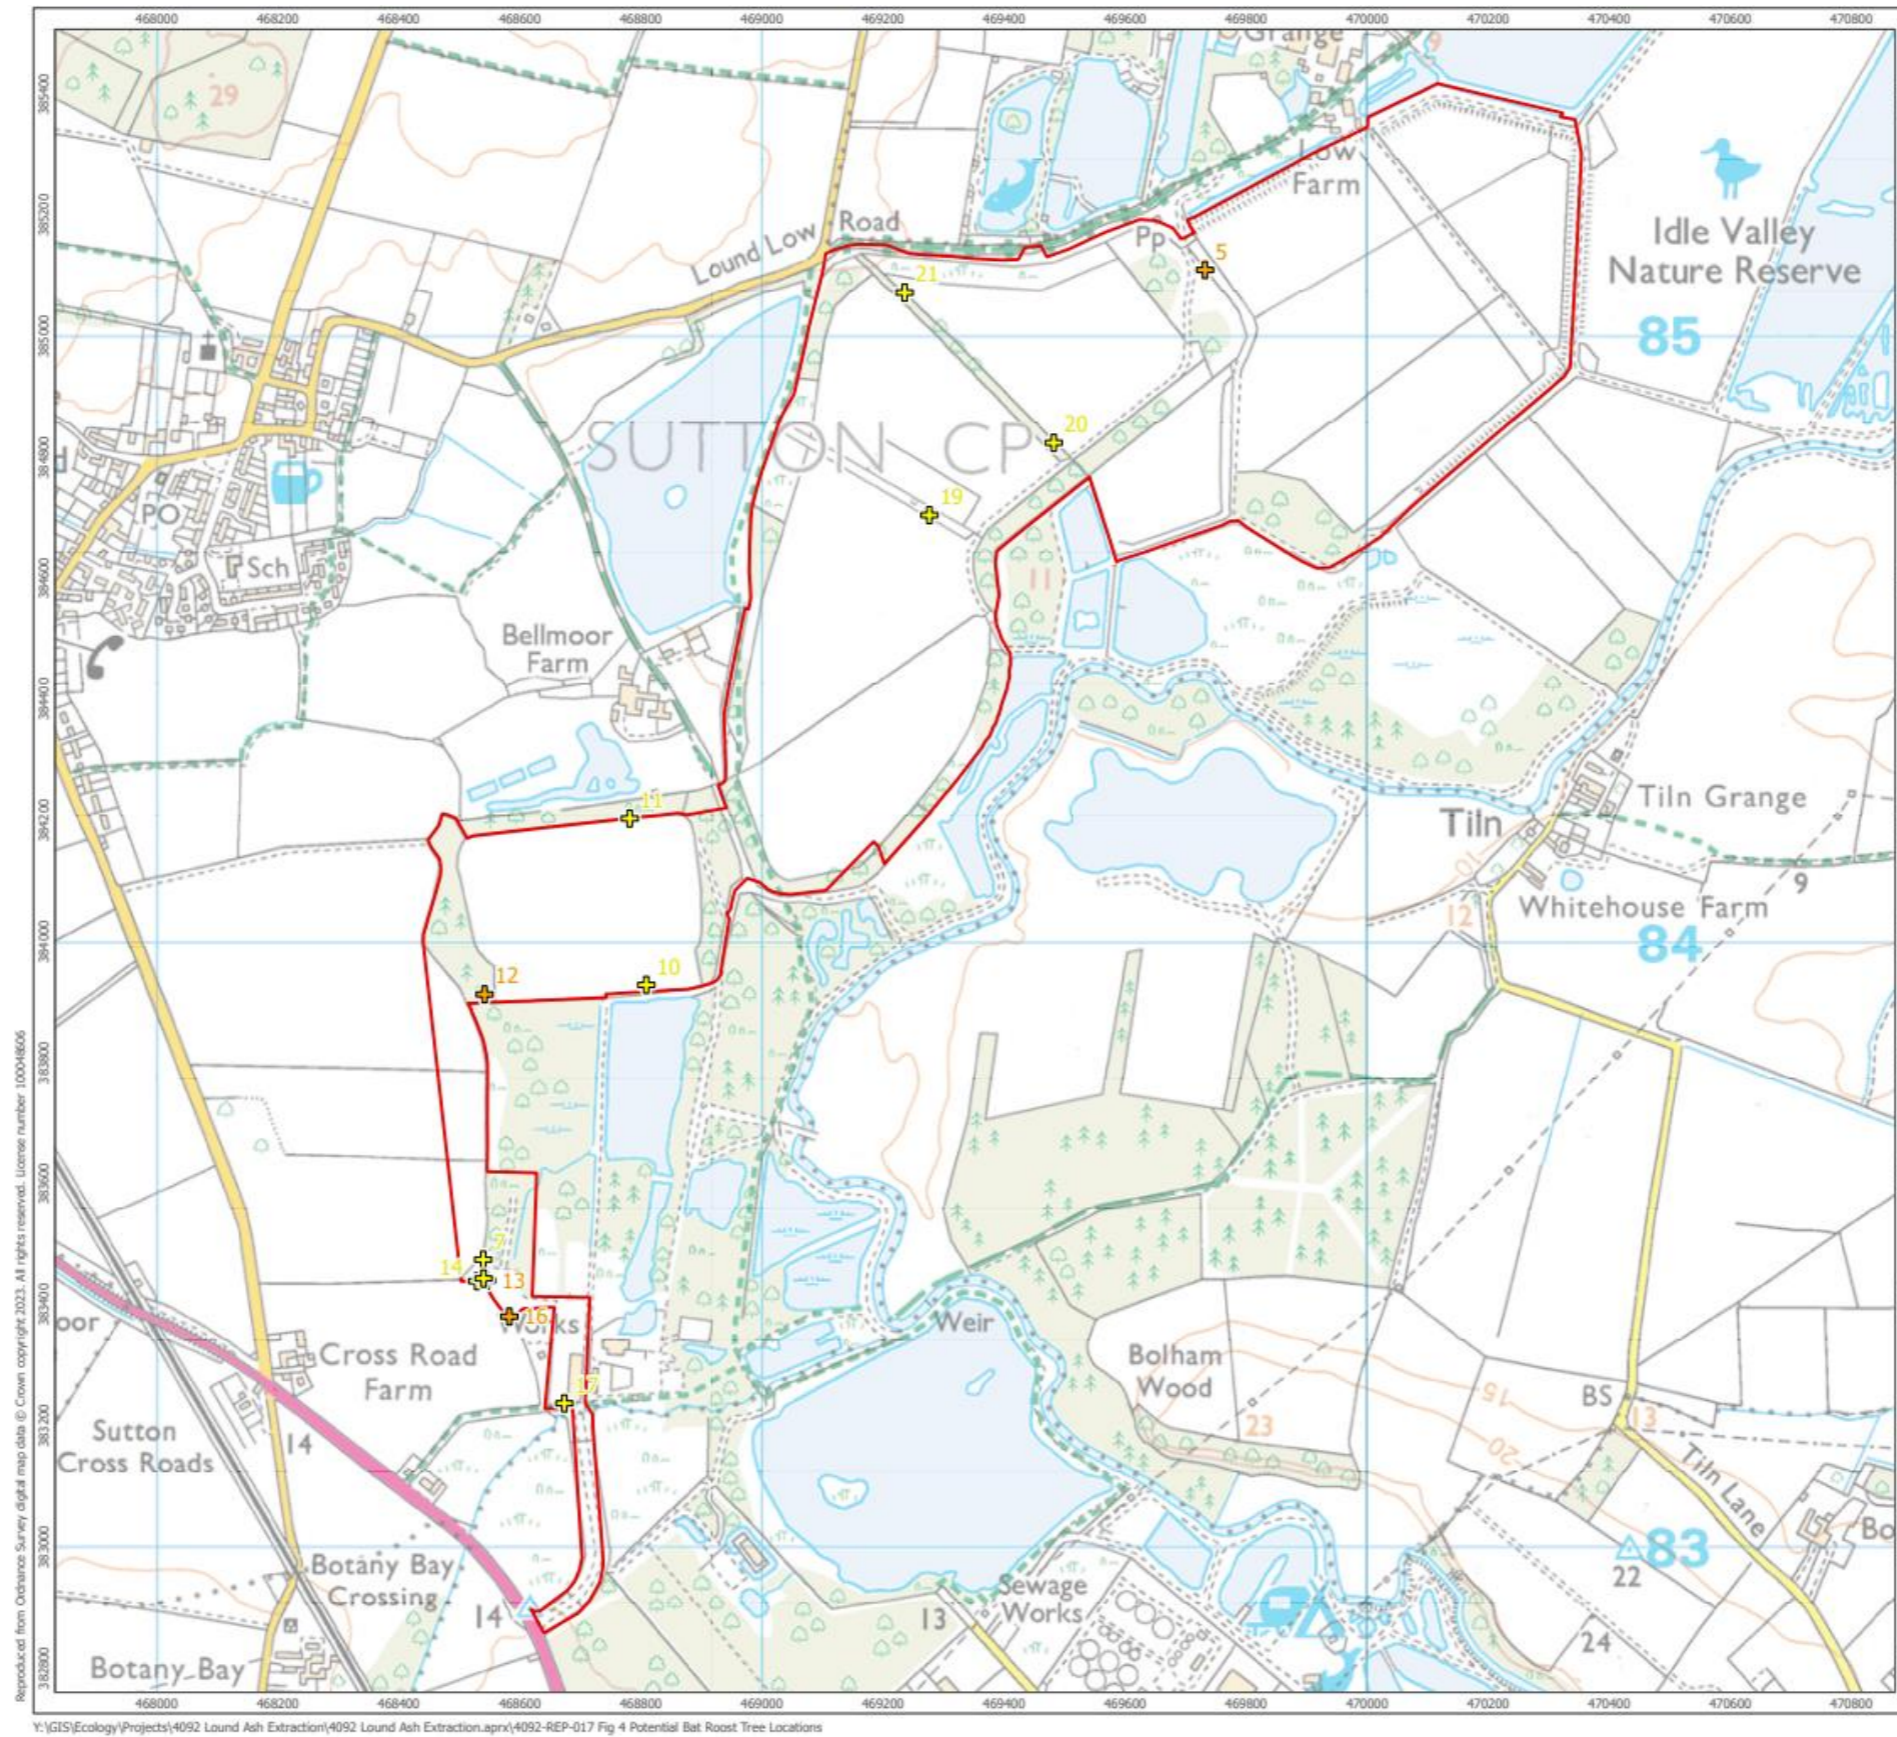
Figure 1: "Potential Bat Roost Tree Locations" (Arcus)

This report has been prepared by Peak Ecology Ltd on behalf of ERM. It provides the results of an aerial tree climbing inspection of 19 trees with suitability for roosting bats, at a site north of Retford, Nottinghamshire. Details of potential roost features were provided following a ground-level tree inspection (GLTA) carried out by Arcus, with the locations of trees shown in Figure 1, below.
